Earl Grey Lithium Project

EPBC Decision 2017/7950 Approval

Annual Compliance Report (2023) - Appendices

JBS&G Australia Pty Ltd | 66747 | Rev 0

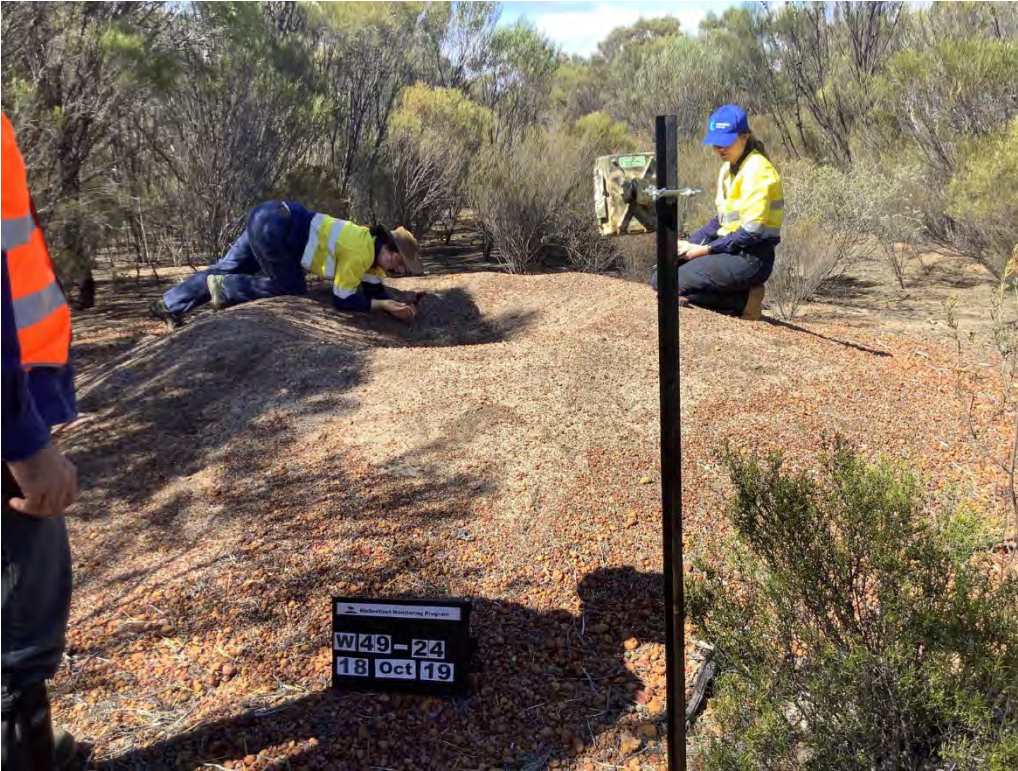
Trail cameras were mounted at annual mounds within and adjacent to the DE. Cameras were mounted on brackets attached to star pickets installed close to the mound and high enough off the ground to view the interior of the mound.

Image 1: Monitored mound showing location of post and camera

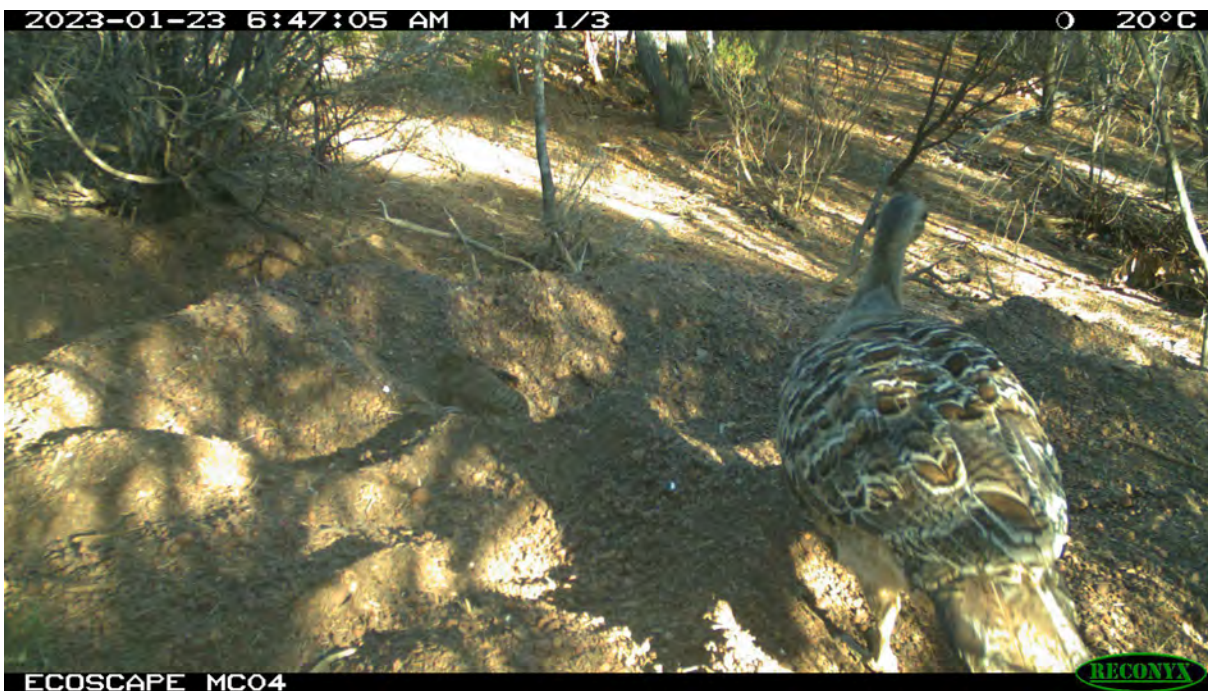
The review of trail camera footage identified that at five out of the six active mounds Malleefowl chicks have emerged (**Table 2**). During the 2022-23 monitoring season at least ten live chicks have left active Malleefowl mounds (**Image 5**). In addition one potential chick was observed at MM76 mid December 2022 and one dead chick was observed at the end of January 2023 (**Image 6** and **Image 7**).

Image 5: Malleefowl chick at mound MM62

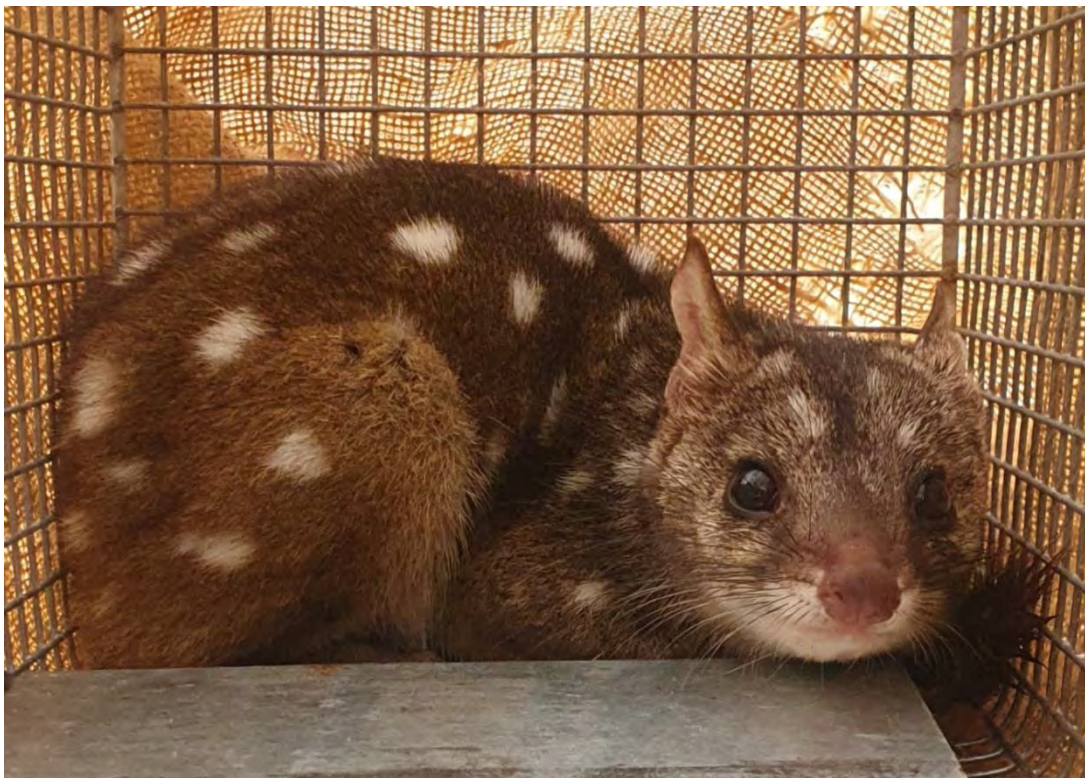
One male Chuditch was captured in a cage trap during the 2023 monitoring event (**Image 1**). The capture occurred in the control site, in unburnt Mallee woodland, adjacent to dense shrubland (**Image 2**). The Mallee woodland had several dead Salmon Gums (*Eucalyptus salmonophloia*) nearby, providing hollow logs for denning, although no dens were located. The capture was weighed, measured, and tagged with a Passive Implant Transponder (PIT) tag (**Table 2**). The animal was in good condition with no recorded bite marks or parasites and did not exhibit any previous capture marks or tags.

Image 1: Male Chuditch captured at trap 25, control site “Chuditch A” (Map 1)

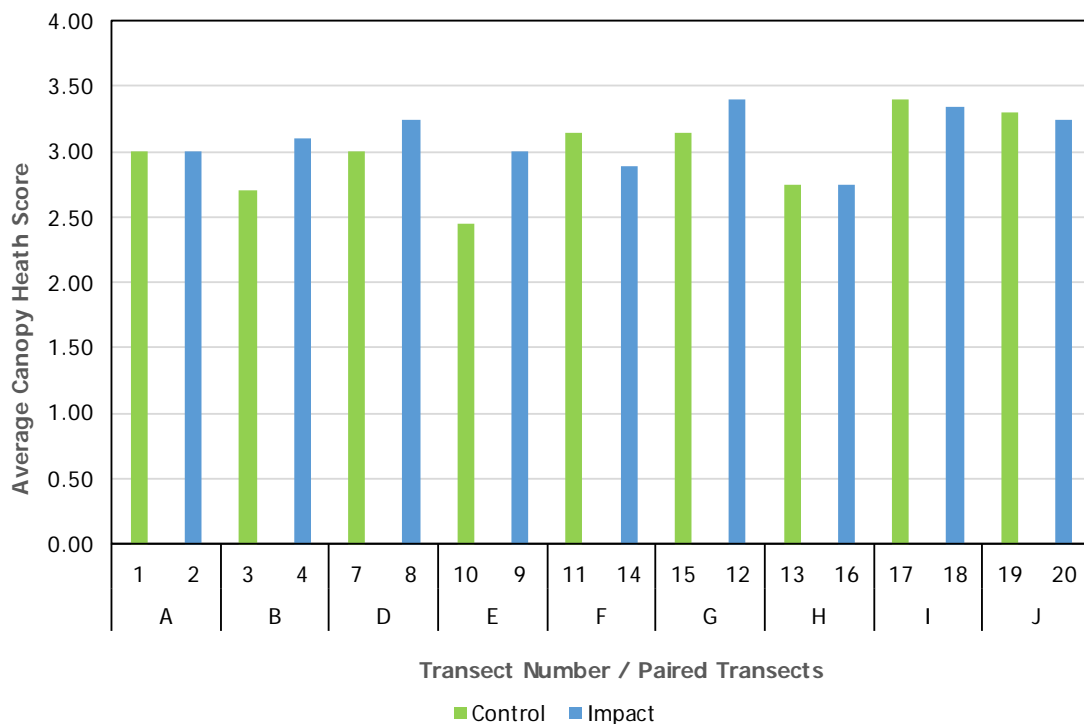
Figure 5 shows four of the impact transects increased canopy health compared with the control (pairs B, D, E and G), whilst three control transects (pairs F, I and J) show a decline in canopy health compared with their corresponding impact transects. Two of the transects show no difference (pairs A and H).

Figure 5: Average canopy health scores for 20 tagged plants at each plant condition monitoring transect, November 2023
 Paired control/impact transects are indicated by the letters A through J. Canopy health scores: 0 dead; 1 very stressed; 2 stressed; 3 slightly stressed; 4 healthy. Refer to Table 3 for a detailed description of each health score.

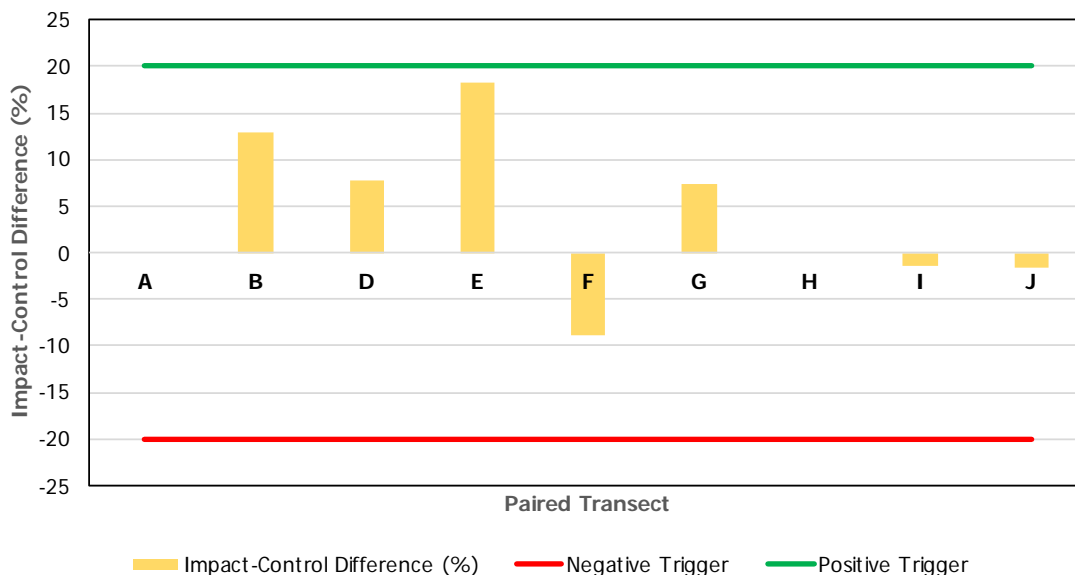
Figure 6: Control-Impact paired transect differential health scores, November 2023
 The percentage difference between the control, and impact transects are shown, together with positive and negative trigger values.

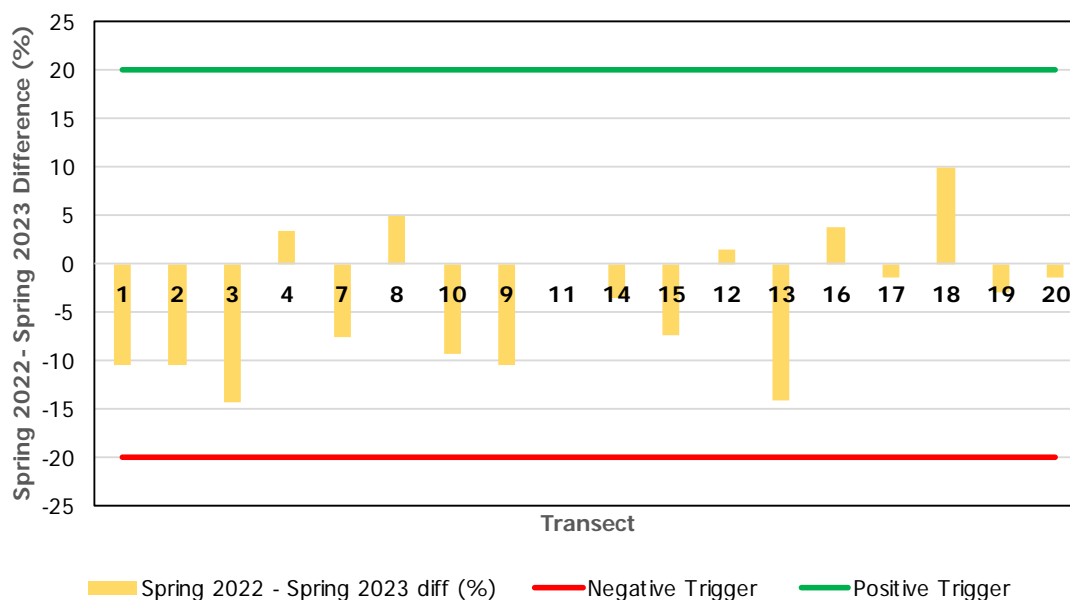
Figure 7 shows the percentage difference in mean canopy health score between September 2022 (the last spring survey) and November 2023 (this survey). The largest decrease in average canopy health scores between this year and last year were observed at control transect 3 (-14.28%), and transect 13 (-14.06%). The largest increase in average canopy health scores were observed at impact transect 18 (9.83%). The overall trend shows an average decline in canopy health by -3.89%.

Figure 7: Percentage difference in average canopy health scores for 20 tagged plants, between September 2022 (last spring survey) and November 2023 (this survey) at each vegetation health monitoring transect

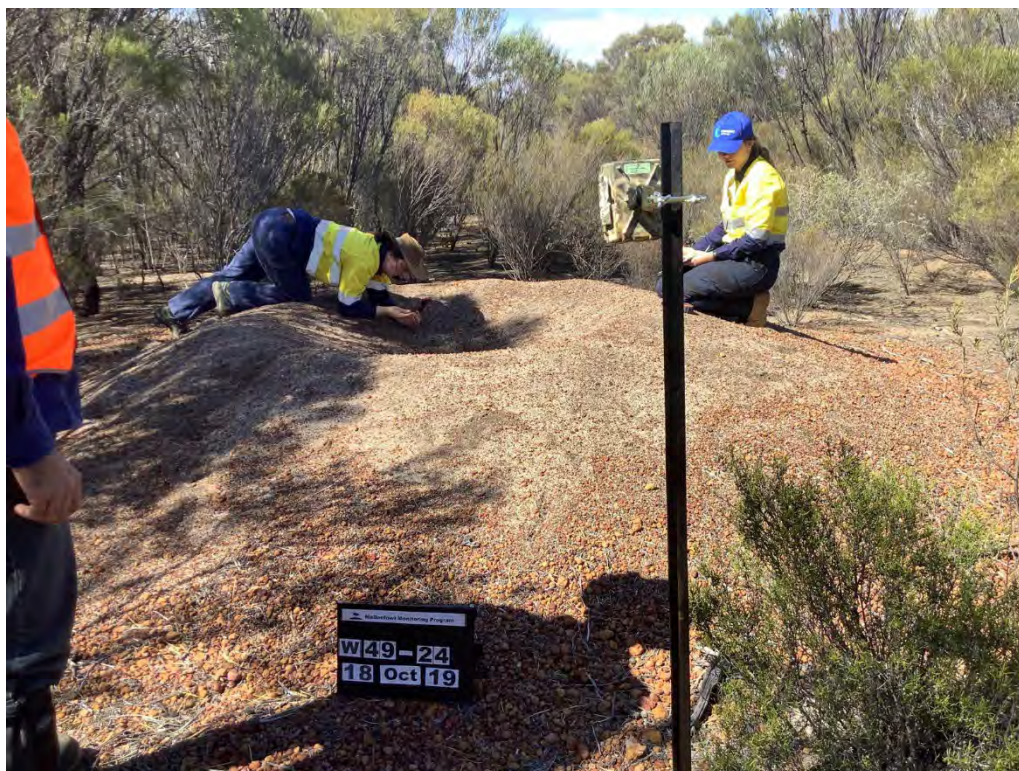
Trail cameras were mounted at mounds within and adjacent to the DE. Cameras were mounted on brackets attached to star pickets installed close to the mound and high enough off the ground to view the interior of the mound (**Image 1**).

Image 1: Monitored mound showing location of post and camera

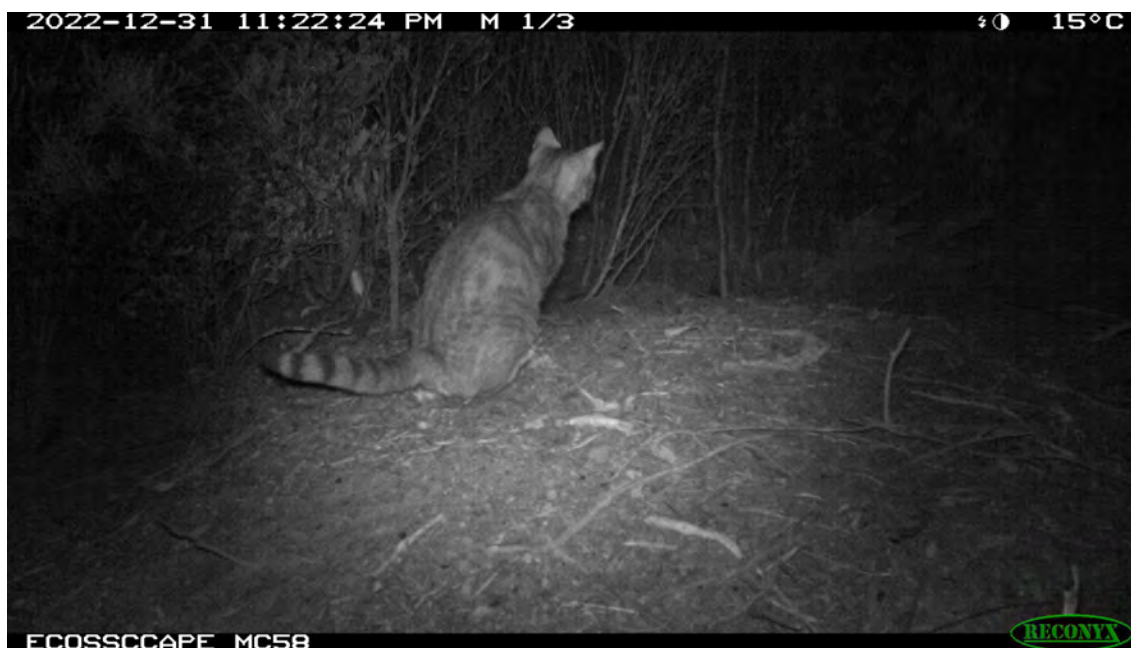
Feral Cats were recorded by trail cameras at 9 Malleefowl mounds in 2022 (Images 2, 4, 5). Dogs were recorded at mound MM24 and twice as observations between the Village and the mine administration office in 2022 (Image 3).

Image 2: Feral Cat recorded at mound MM63

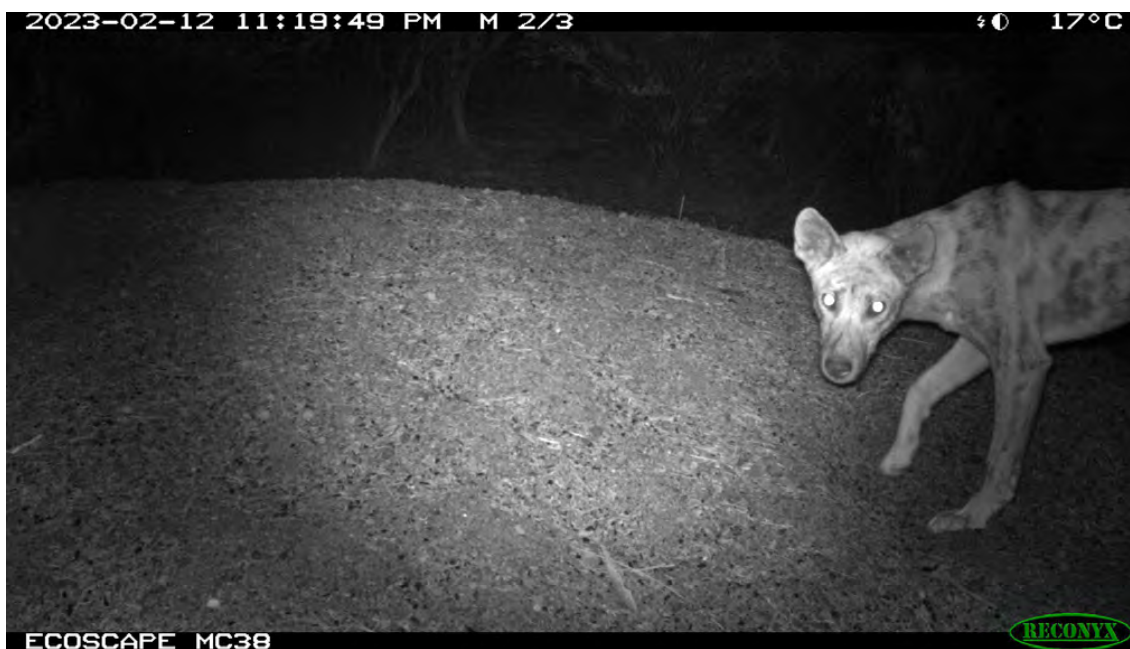
Image 3: Dog/Dingo at mound MM24

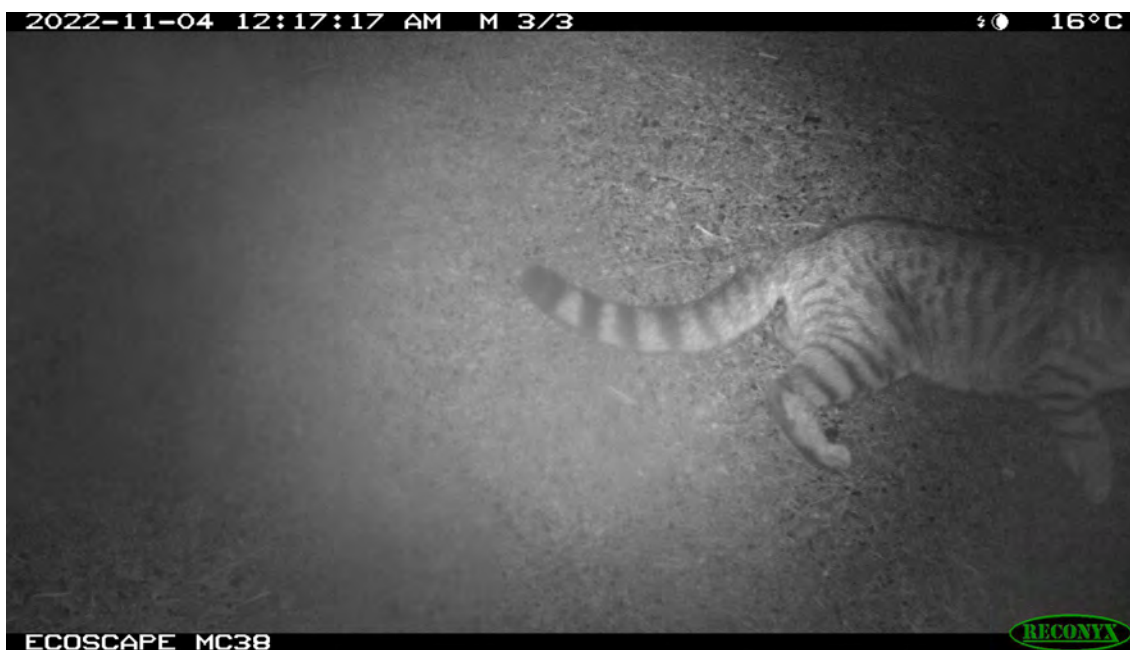
Image 4: Feral Cat recorded at mound MM24

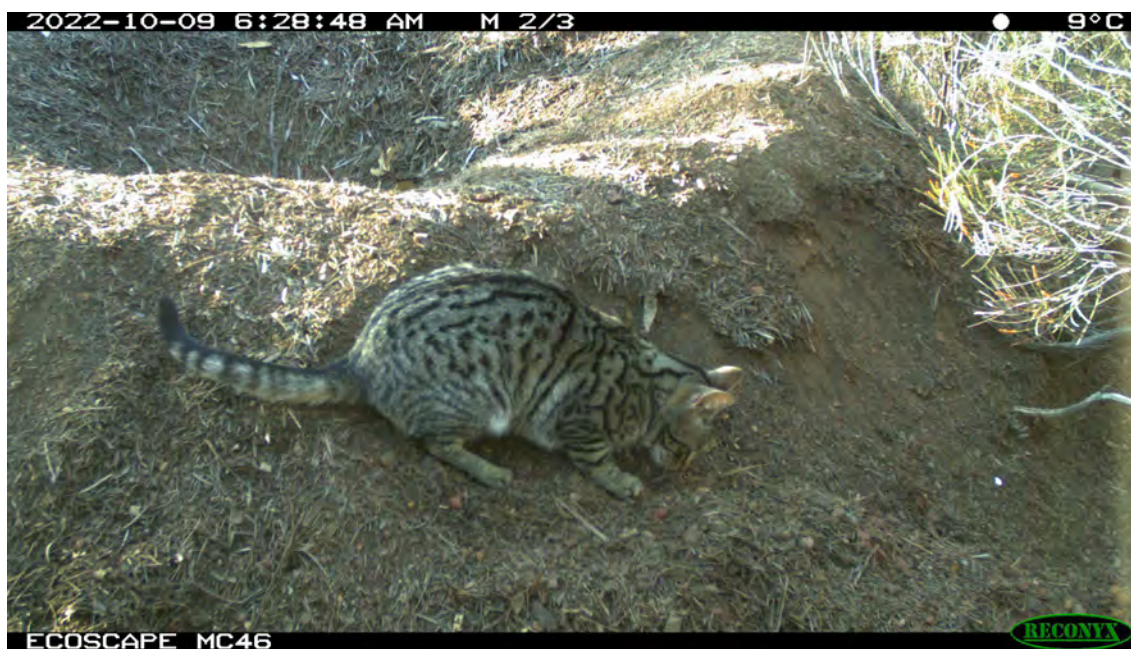
Image 5: Feral Cat recorded at mound MM64

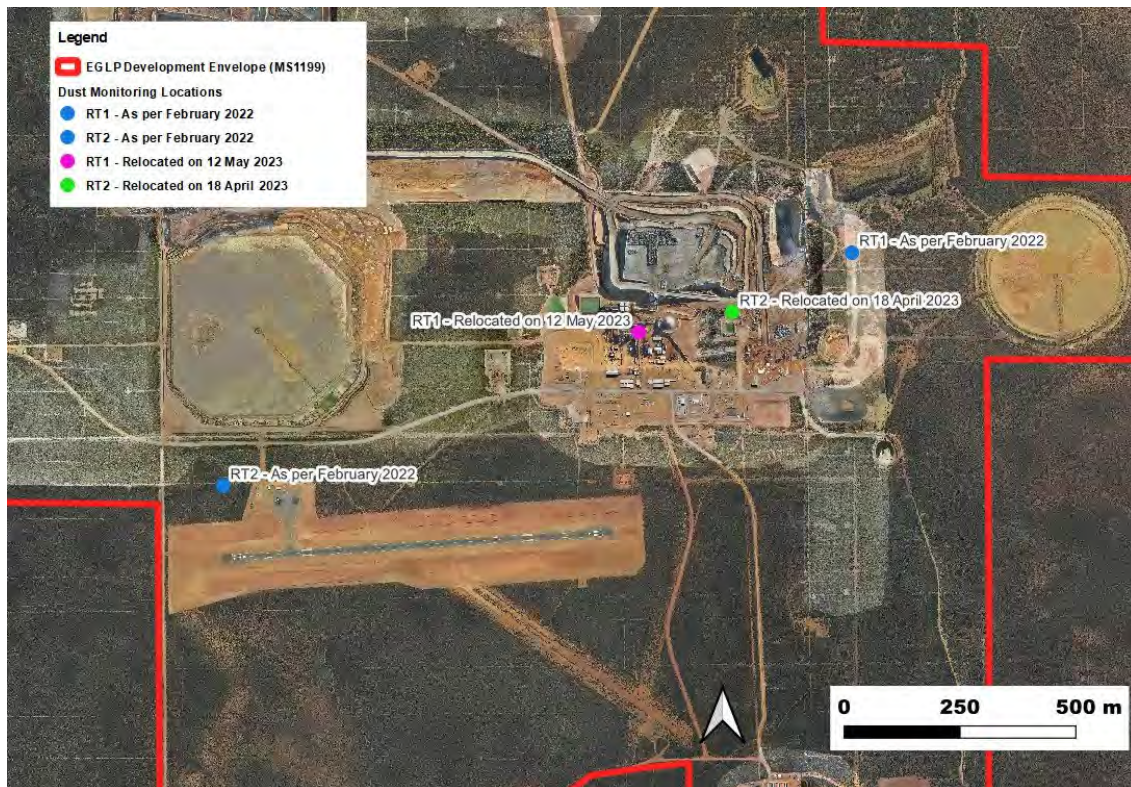
The monitoring stations were installed in July 2021 and operated continuously until the end of June 2023. A separate report was prepared for the first part of the project (June 2021 – September 2022) and this document deals with the data from October 2022 until the end of the monitoring program (June 2023). The realtime monitoring stations were relocated during this period as shown in the following image.

Image 1 – Realtime dust monitoring locations

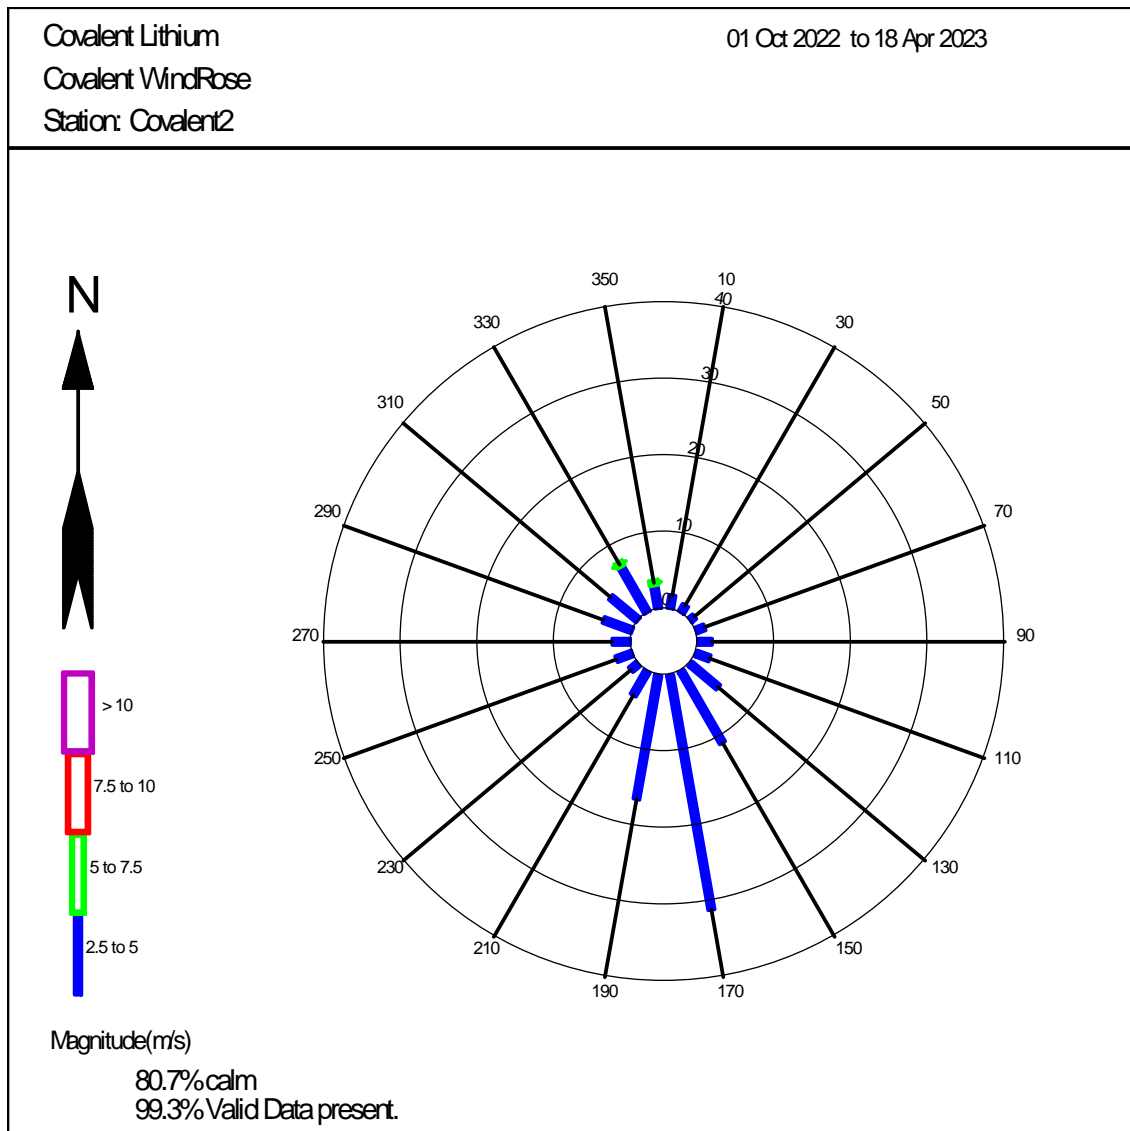
An Australian Standard weather station is not available on site and for this project a local wind vane was used to collect wind information. The sensor was located at the Station 2 site, 1.8m above ground and sampled at the same frequency as the PM10 monitor. The wind roses below show the data collected during the first period (01/10/2022 – 18/4/2023) and the second period (18/4/2023 – 30/6/2023).

Image 2 – Wind Rose, Station 2, 01/10/2022 – 18/4/2023
