# Earl Grey Lithium Project

Covalent Lithium Pty Ltd

**2023 Compliance Assessment Report – Ministerial Statement 1199**

JBS&G 666747

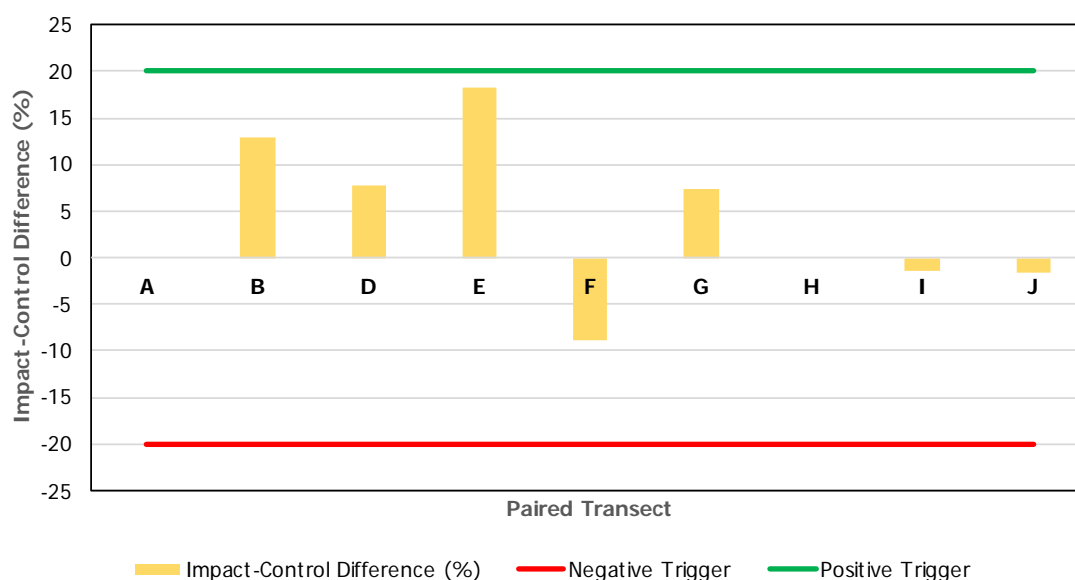
**Figure 6: Control-Impact paired transect differential health scores, November 2023**

The percentage difference between the control, and impact transects are shown, together with positive and negative trigger values.

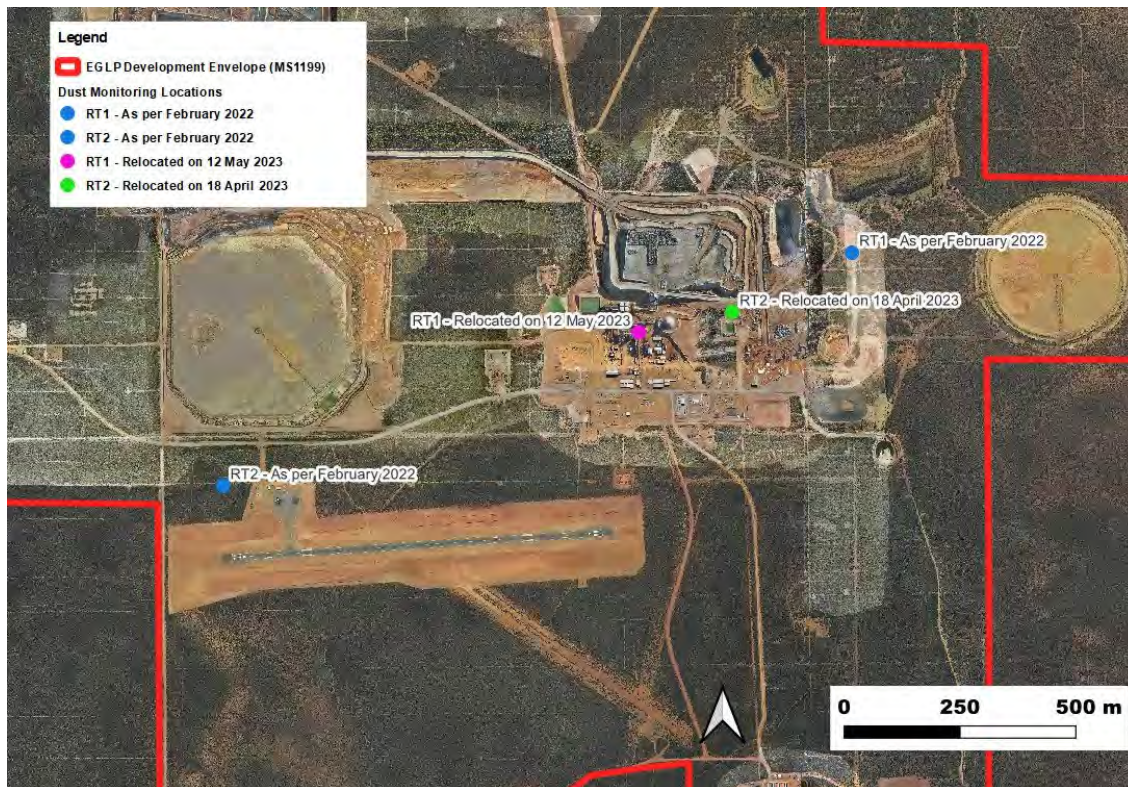
*Image 1 – Realtime dust monitoring locations*

The monitoring stations were installed in July 2021 and operated continuously until the end of June 2023. A separate report was prepared for the first part of the project (June 2021 – September 2022) and this document deals with the data from October 2022 until the end of the monitoring program (June 2023). The realtime monitoring stations were relocated during this period as shown in the following image.

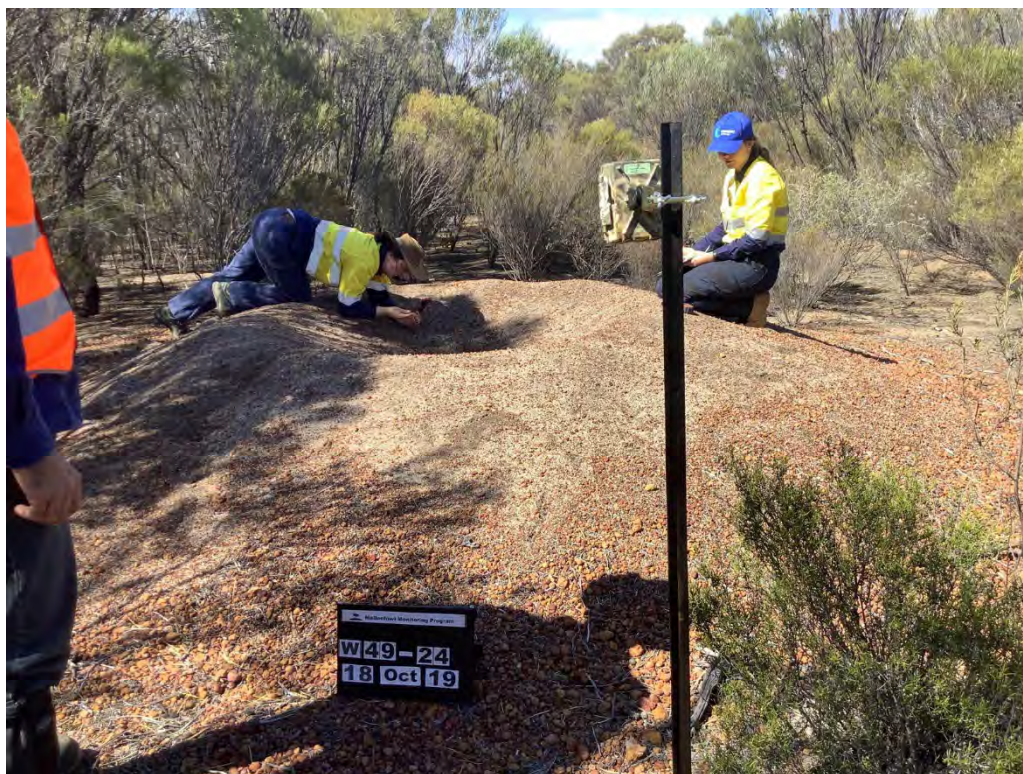
**Image 1: Monitored mound showing location of post and camera**

Trail cameras were mounted at annual mounds within and adjacent to the DE. Cameras were mounted on brackets attached to star pickets installed close to the mound and high enough off the ground to view the interior of the mound.

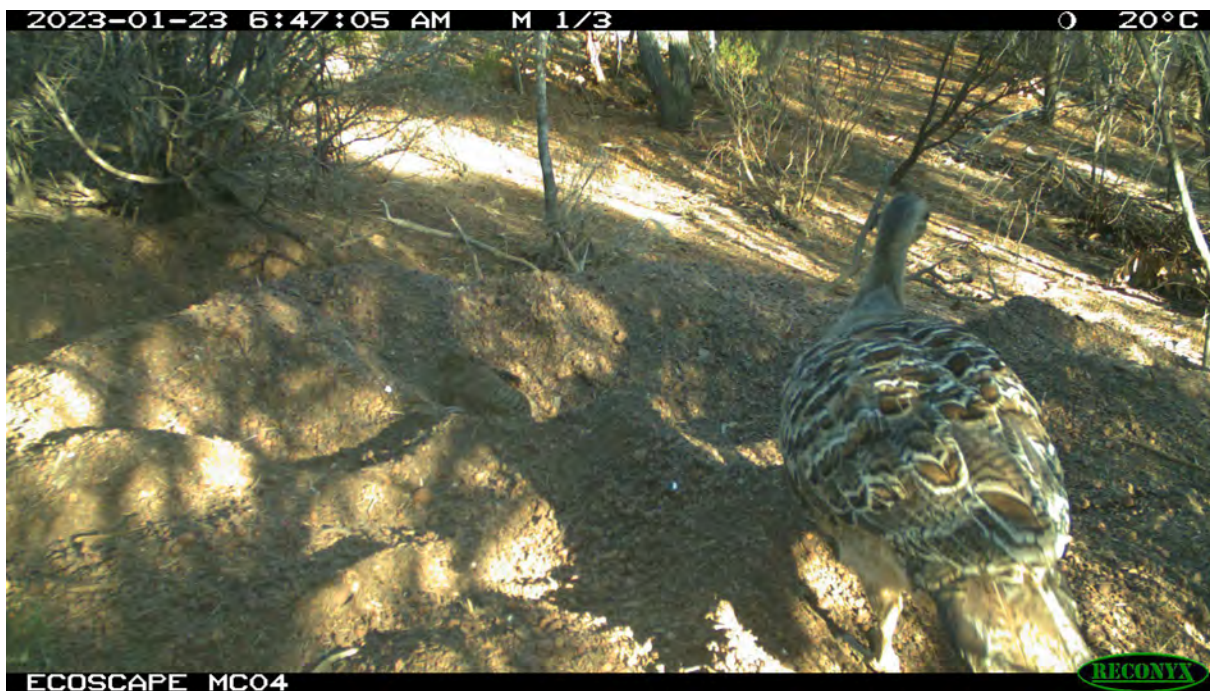
**Image 5: Malleefowl chick at mound MM62**

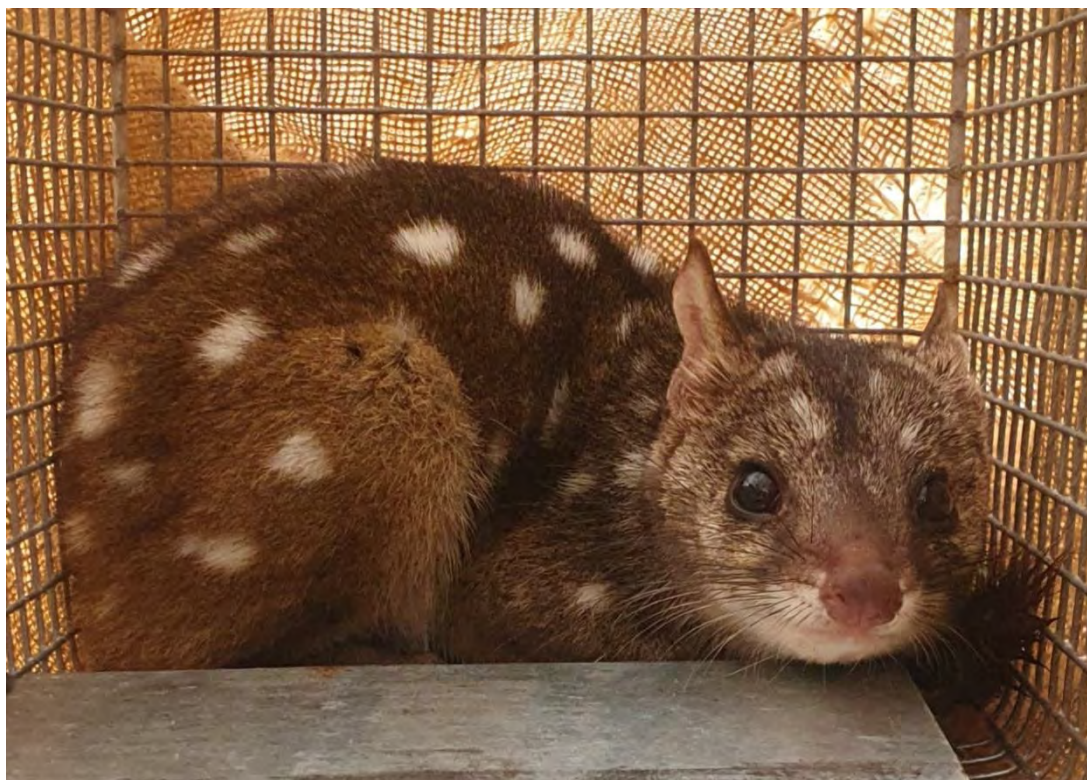
**Image 1: Male Chuditch captured at trap 25, control site “Chuditch A” (Map 1)**

One male Chuditch was captured in a cage trap during the 2023 monitoring event (**Image 1**). The capture occurred in the control site, in unburnt Mallee woodland, adjacent to dense shrubland (**Image 2**). The Mallee woodland had several dead Salmon Gums (*Eucalyptus salmonophloia*) nearby, providing hollow logs for denning, although no dens were located. The capture was weighed, measured, and tagged with a Passive Implant Transponder (PIT) tag (**Table 2**). The animal was in good condition with no recorded bite marks or parasites and did not exhibit any previous capture marks or tags.

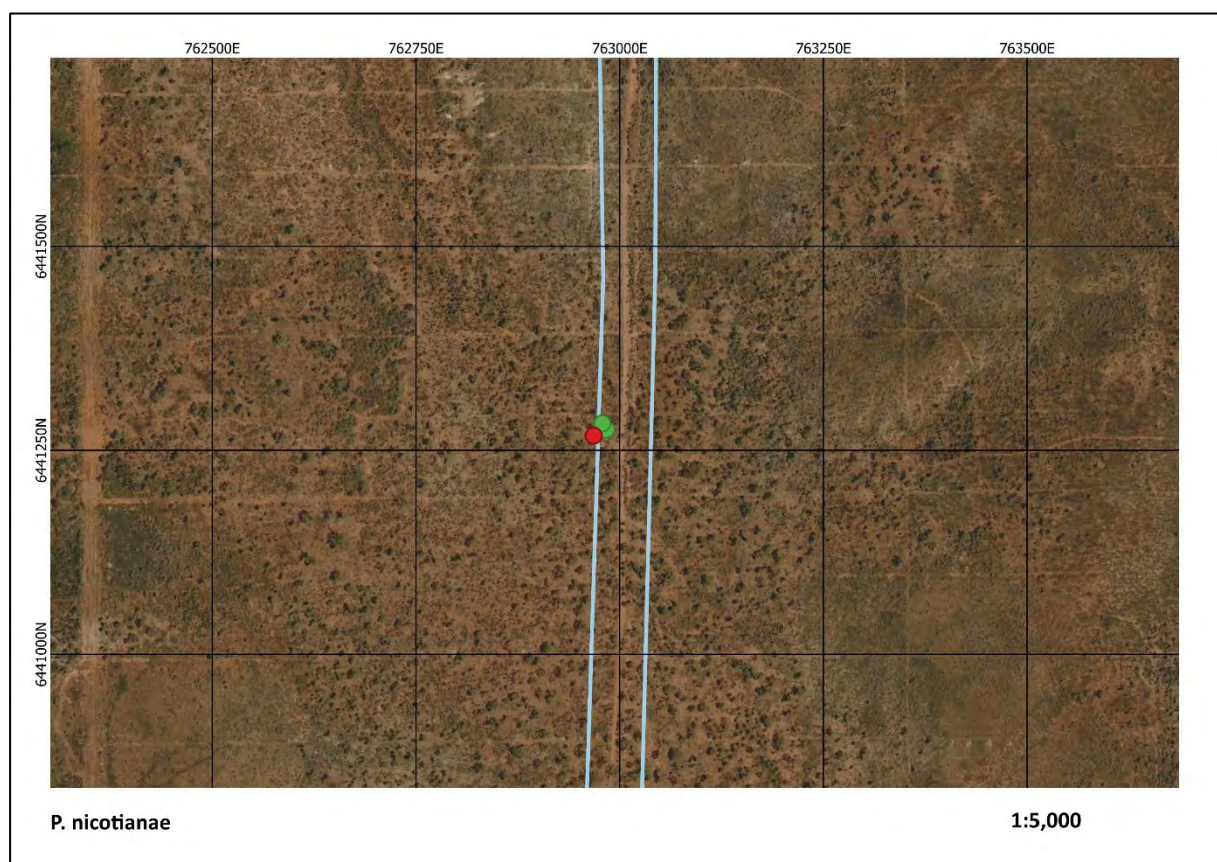
Figure 1 - *P. nicotianae* site

The *P. nicotianae* site (Figure 1) identified in 2019 (Sample ID CC2031, Table 5) was sampled again in 2021 (Sample ID 1, Table 5) and 2022 (Sample ID 3, Table 5). These subsequent samples have not recovered Phytophthora. This site has a small drainage line which may have allowed the site to achieve optimal conditions in 2019 to express the disease.

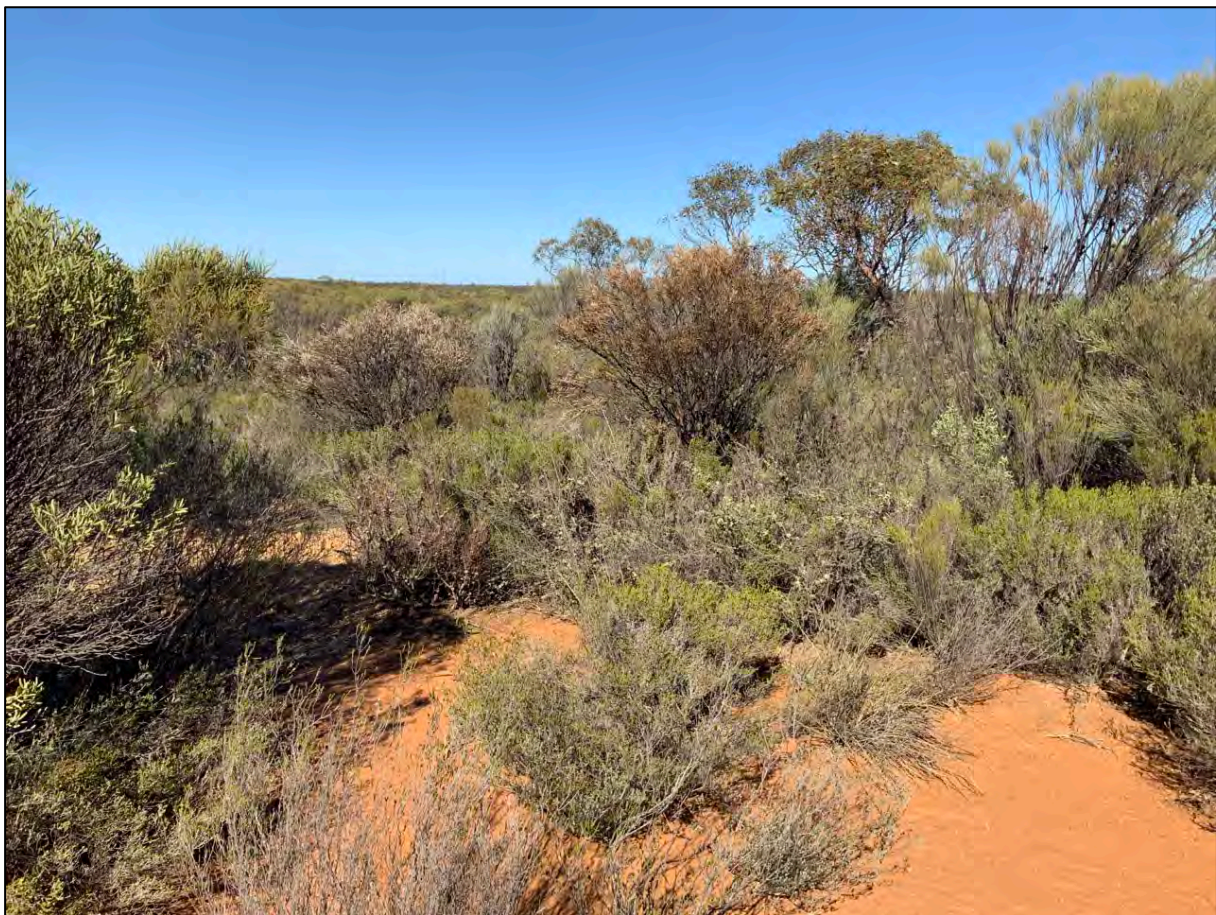
**Figure 2 - Sample ID 20, photo from 2021 survey**

When the site was revisited in 2022, no recent deaths were observed, which again is typical of the author's experience with other *P. arenaria* sites in Western Australia.
